USB Box accessoire – 9702EZ

## Updating the USB Box accessory to software version V3.04

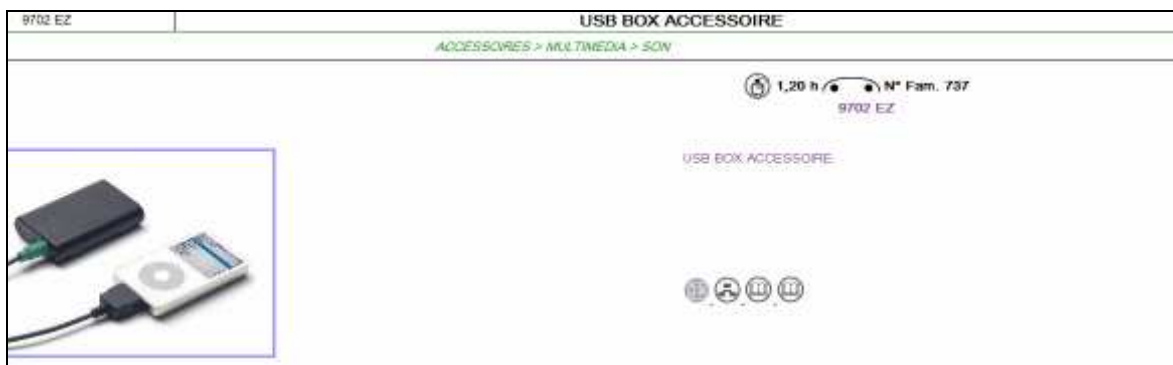
- A standard PC,
- A 2MB minimum USB key,
- The V3.04 USB Box software: the file "USPA\_UPD-SW 3.04.ROM" can be downloaded at Citroën Service / Service Box in the USB Box product sheet.
